**MARYLAND HISTORICAL TRUST
NR-ELIGIBILITY REVIEW FORM**

Property Name: Microbiological Associates Building Inventory Number: F-3-105

F-3-105

INVENTORY FORM FOR STATE HISTORIC SITES SURVEY

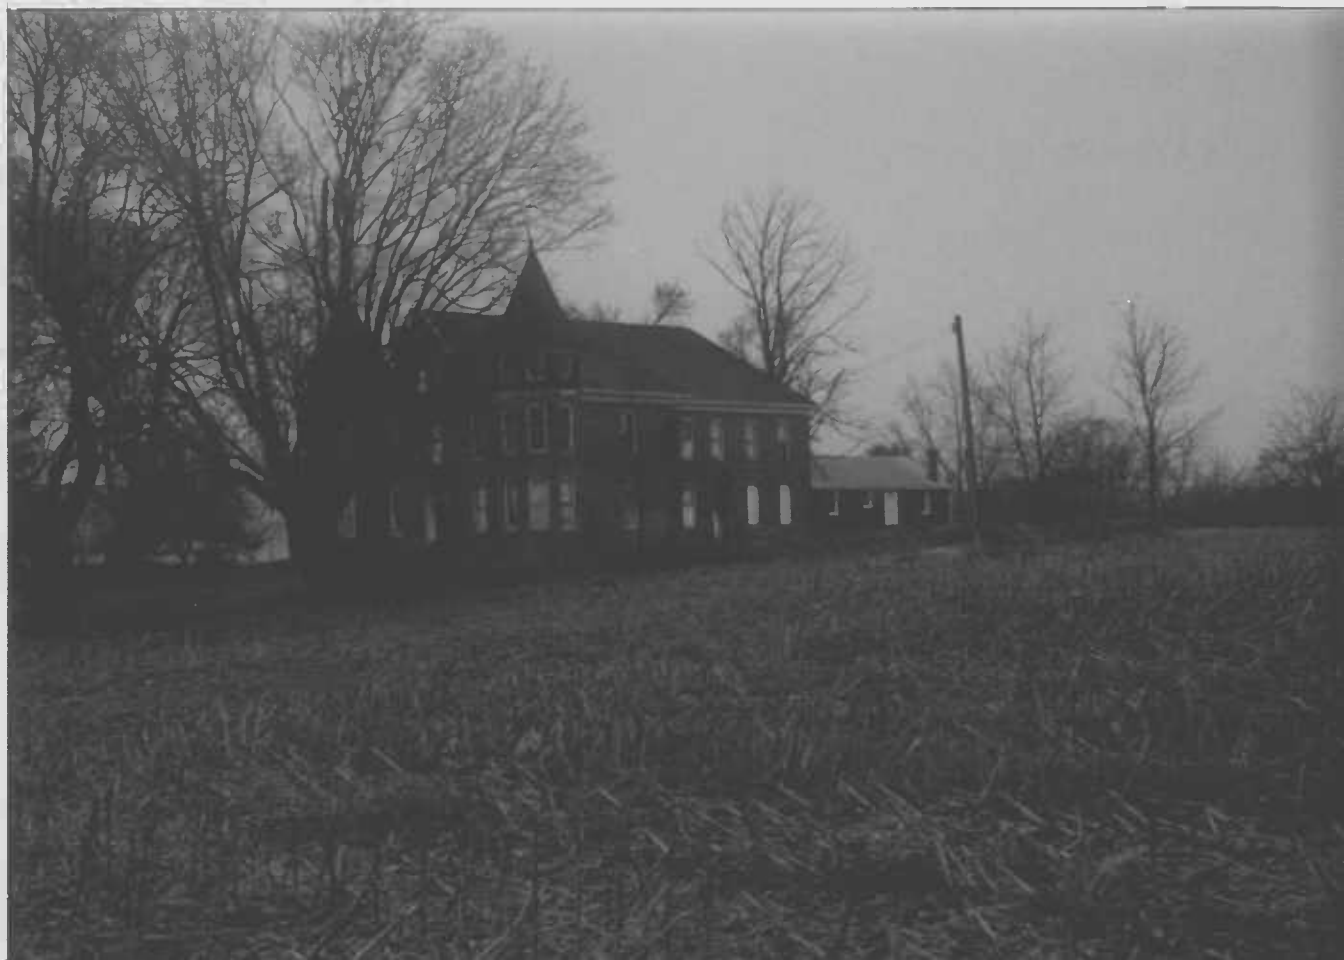
1/4

The building's principal (east) facade is symmetrical and features a central entrance containing a wood four-panel door. At the attic level, the corner turrets feature windows. The central gabled dormer contains a Palladian window. The Palladian window contains a six-over-six-light, wood-sash window with a round-arched lintel flanked by one-over-one-light, wood-sash windows.

EAST AND NORTH FACADES, VIEW TO SOUTHWEST

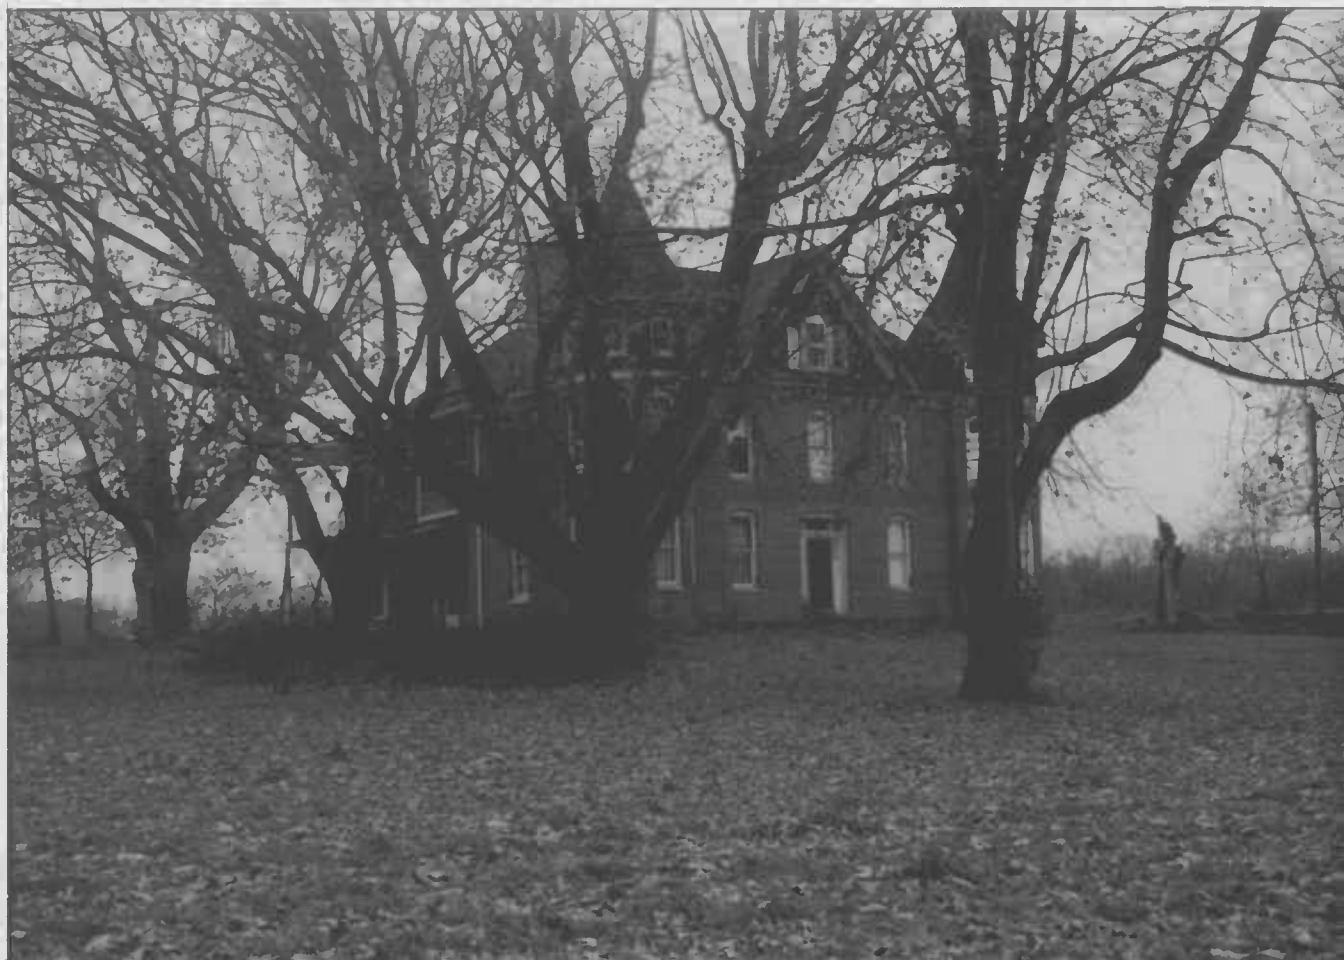
2/4

The main block of the building extends to a depth of two bays, while a four-bay ell continues the building to the rear (west). The ell's side facades feature entrances containing four-panel wood doors with transoms, two on the south and one on the north facade. The ell's south facade also features a one-story full-width balcony. The balcony features square posts and a balustrade of square balusters.

SOUTH AND EAST FACADES, VIEW TO NORTH WEST

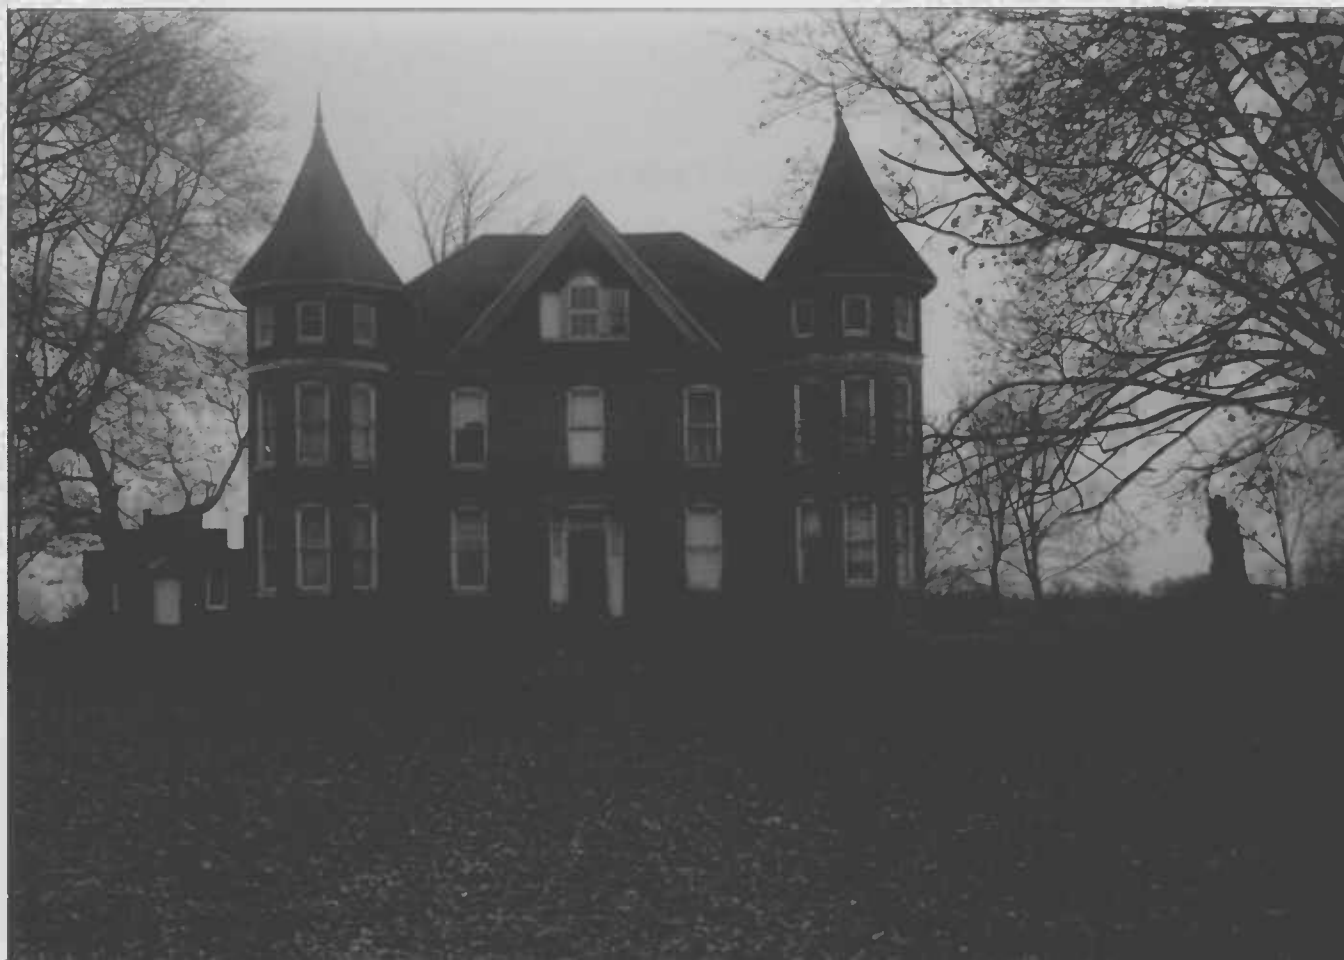
3/4

EAST FACADE, VIEW TO WEST

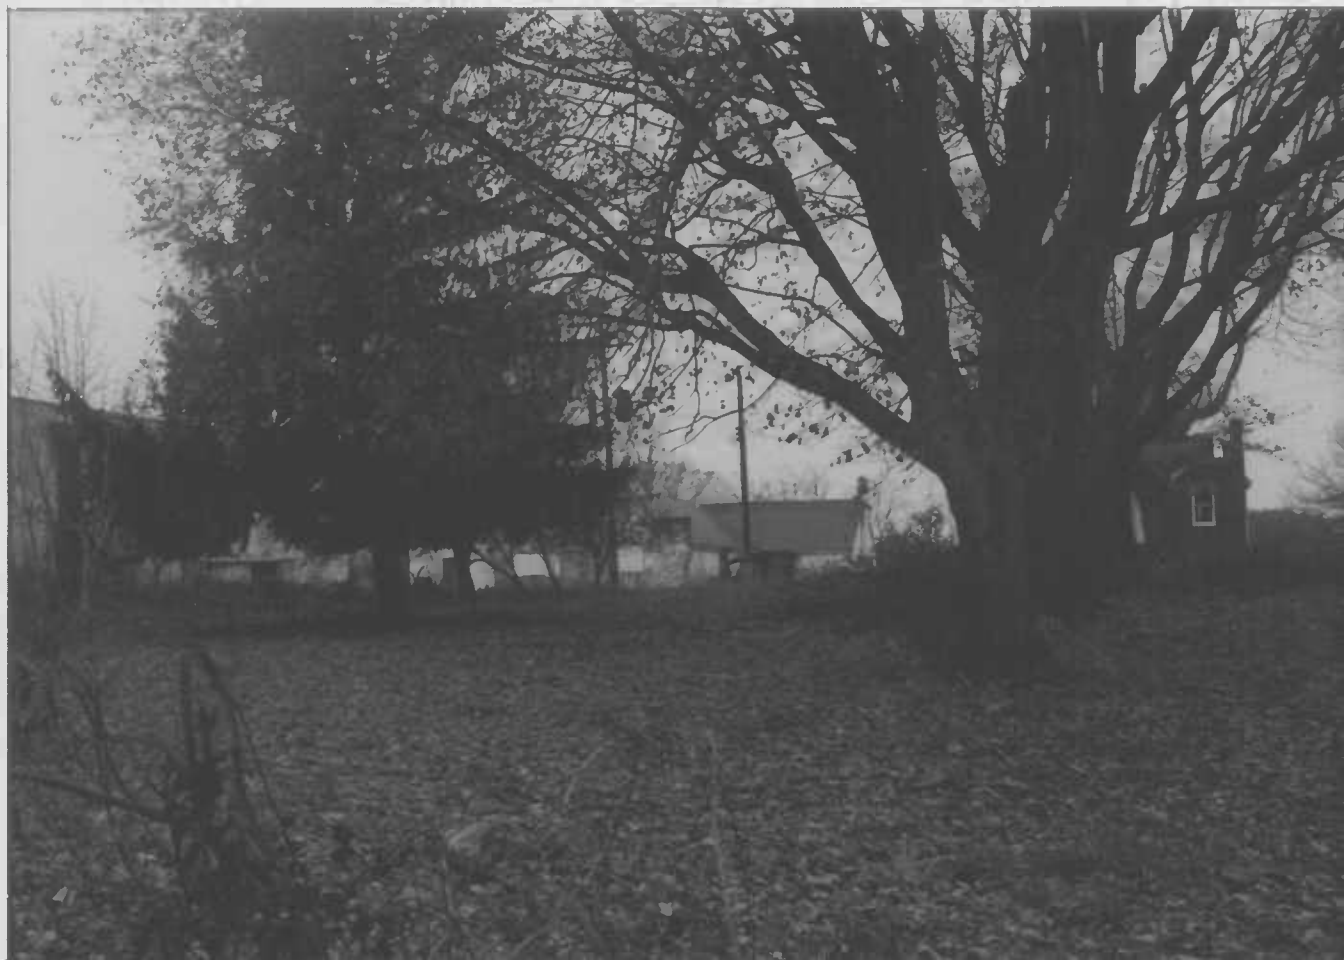
4/4

Three outbuildings are located south of the main house. A one-story brick storage building features a gable roof with a stepped parapet. The building is three bays wide and four bays deep. The building's principal (east) facade features a central entrance containing a six-panel wood door. The window openings feature wood lintels and brick sills, and contain one-over-one double-hung wood sash. Two brick chimneys are located on the north elevation.

A second one-story outbuilding stands south of the first. The principal (east) facade of the building features a stepped parapet. The building is two bays wide and adopts an L-shaped footprint. The building is constructed of concrete block with a front facade faced in brick. The building terminates in a gabled roof sheathed in standing-seam metal roofing.

The third outbuilding, constructed ca. 1960, stands east of the second and appears to be a small factory or warehouse. The two-story building is constructed of concrete block. The building features a flat roof. The building's walls are blind. A wood addition is appended to the building's south facade.

OUTBUILDINGS' EAST FACADES, VIEW TO WEST

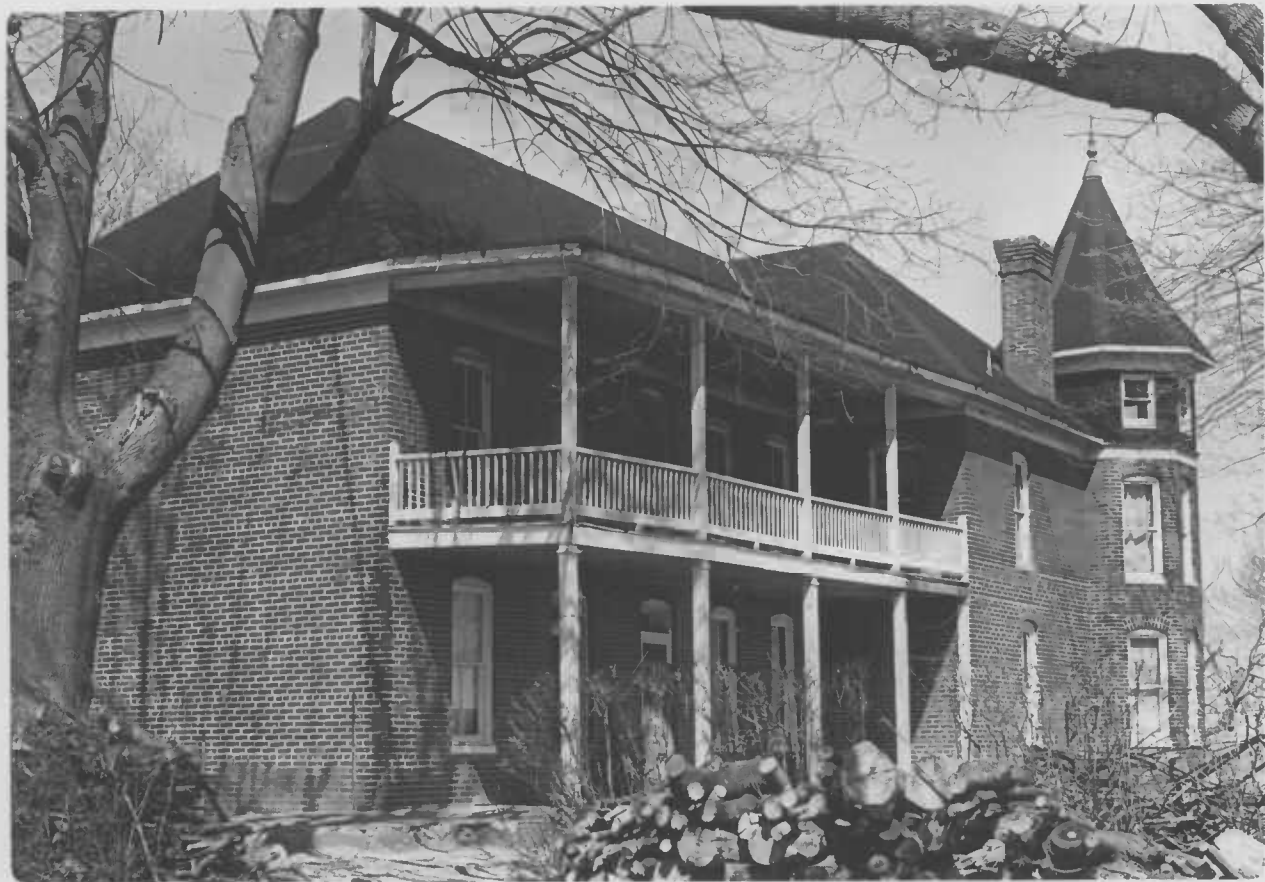
The building extends to the rear (west side), six bays deep. Double hung 2/2 windows occupy each bay. An entranceway is located in the third bay. A two story open porch extends along the entire south side of the building.

MICROBIOLOGICAL ASSOC. BUILDING
W/S BALLENGER CREEK PIKE
WEST ELEVATION

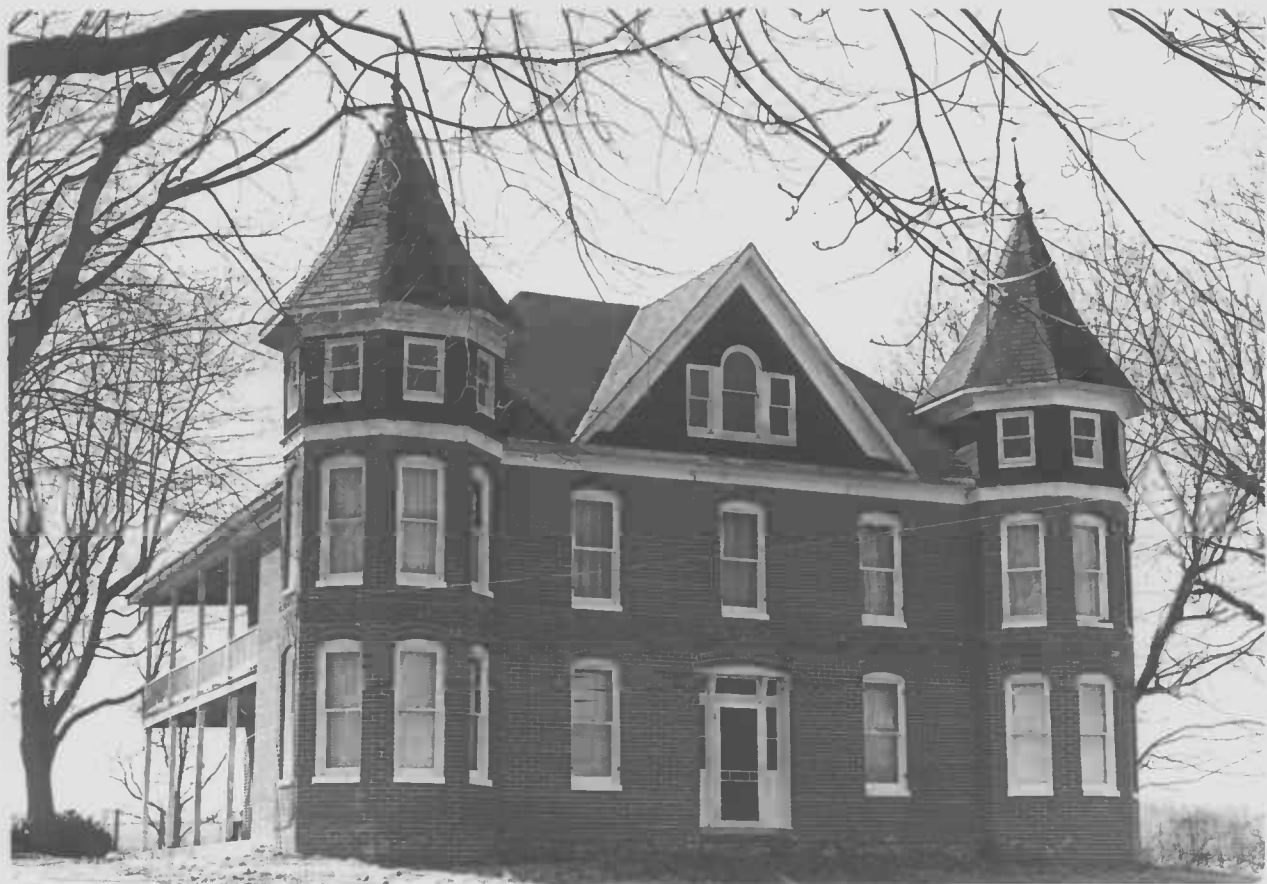
This house is a large two story brick residence laid in common bond which faces east from the west side of Ballenger Creek Pike. The principle facade is nine bays wide; the main entrance, a panelled door with circular medallion decoration, three light transom and two side lights is located in the fifth bay. The remaining bays are 1/1 windows with double header arches.

The front of the building is dominated by two large three story pentagonal turrets which set in the north and southeast corners of the building. Small clerestory windows are located in the third level of the turrets. Both turrets are covered by asphalt pyramidal roofs with finials. A front gable with arched window extends from the hipped roof.

MICROBIOLOGICAL ASSOC. BUILDING
W/S BALLENGER CREEK PIKE
EAST ELEVATION
